Tech Bulletin:

Aura Pro Cervélo Custom Edition aerobars fitted to some 2013 Cervélo bicycles: issue with clamp fixing bolts

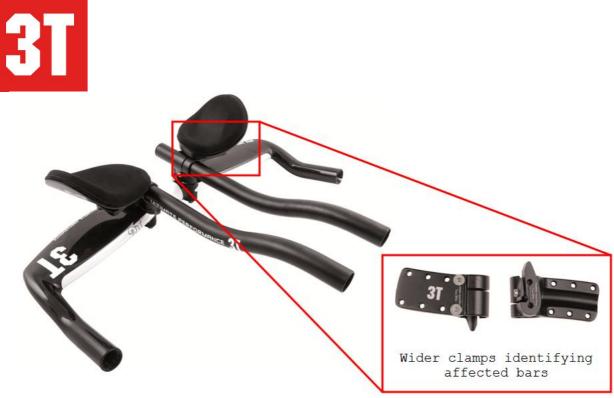
Aura Pro Cervélo Custom Edition aerobars supplied to Cervélo and fitted to certain models of Cervélo bicycle sold from September 2012 and listed below. Bars on these bicycles have wider clamps than standard Aura Pro bars – this is shown in figure 1. Standard Aura Pro bars sold to aftermarket retail customers are not affected.

Figure 1: wider clamps on an Aura PRO aerobar

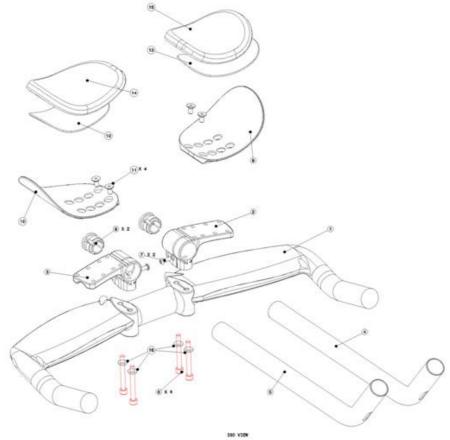
The bolts fixing the clamps may be too short for the increased overhang of the wider clamps and may not provide sufficient engagement to secure the clamp.

Bolts are shown in red, position 6, in figure 2 below.

Figure 2: affected bolt on Aura PRO bar in Cervélo version

Affected bolts have been delivered in M5 x 35 mm DIN912 specification. New bolts are specified as M5 x 45 mm DIN912, in order to guarantee the highest safety standards available.

We want to stress that this issue affects only bars delivered with a Cervélo bike that have the wider clamps shown in figure 1. If you are an owner of such a bike, please disassemble the affected bolts (as per Figure 2, position 6) and measure their length. If the bolts are less than 45 mm long (affected, wrong bolts are 35 mm), they must be replaced bolts with new, longer (45 mm) bolts.

There is no need to return the bike to your dealer or distributor to solve this issue. Simply replace the wrong bolts with new, longer bolts that 3T or our local distributor will send you, free of charge, to ensure you can ride safely with the minimum of downtime.

Please note that the maximum torque of these bolts is 5 Nm. Always use a calibrated torque wrench. If you are not confident you can successfully install the bolts, please have a qualified cycle mechanic carry this out.
