## Product Safety Recall

ST-250 Braaap Motorcycle – ST250WO0022016

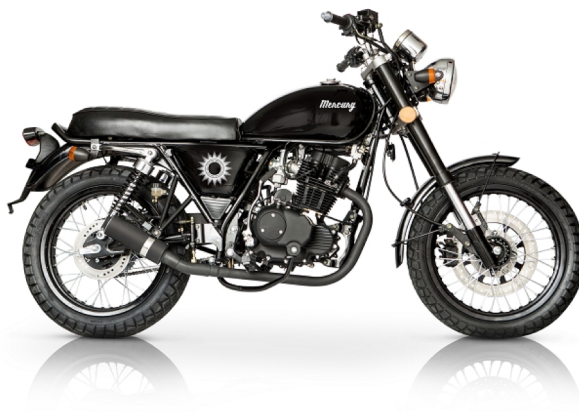
The mandatory requirement is that a motorcycle must have each mechanical component accurately stamped and displayed for identification purposes according to regulation for ADR compliance.

The following parts have been incorrectly stamped for identification purposes.

- Fuel Tap
- Rear Master Cylinder Cap
- Tail light assembly

Display the ADR83 Stationary noise test information sticker

The consumer is unable to verify the authenticity and manufacturing standards of these components and there is the possibility this could lead to the incorrect replacement of parts which may affect vehicle performance and compromise the safety of the rider.

Customers should immediately contact and visit their place of purchase and organize a time to have these components replaced at no expense.
