Product Safety Recall

30/07/10

SpanSet K4 karabiners. Batch No 100329

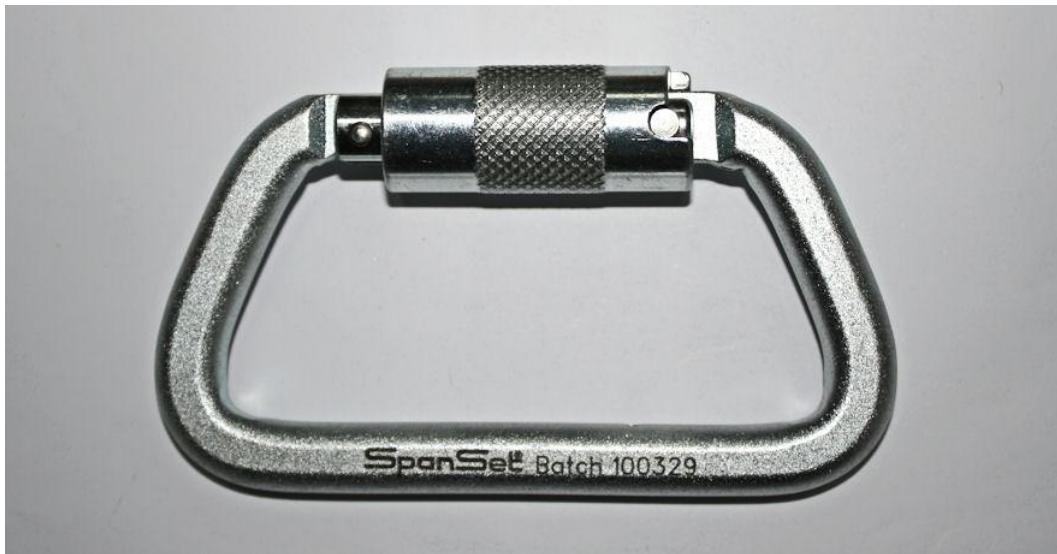
The affected products can be identified by the karabiner carrying the batch number 100329. This is the only affected component. Single karabiners total 474 in quantity

Photo of the affected component and batch number

Users have the option of removing the karabiner and returning it to the supplier or SpanSet Australia Ltd for a replacement, or returning the complete product for re-fitting of the newly tested component.

All replacement karabiners will carry the same batch number with a laser etched marking “Tested 8/10” on the top section of the karabiner. This indicates that the component has been proof loaded to 16kN and safe to use. This exceeds the requirements of AS/NZS 1891.1
