# Product Safety Recall

Disc Brake Rotors  
DBA4418, DBA4418S &  
DBA4418XS

Manufactured by Disc Brakes Australia Pty Ltd in 2013 - 2014  
Installed in selected Mitsubishi Lancer EVO  
model years 1998 - 2007

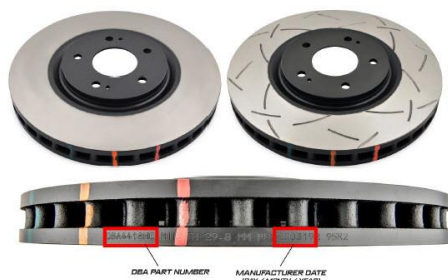
**Defect** If the disc brake rotor experiences a rapid change in temperature, such as during high speed braking in motorsports or similar extreme driving conditions, the rotor may fracture and separate, which may result in brake failure.

**Hazard** If the disc brake rotor fractures, the brake may not function correctly and may fail, posing an accident or injury risk to the vehicle occupants and other road users.

**What to do** Owners of affected vehicles should arrange to check the rotor number of their disc brake rotors. If the rotor is from the affected DBA4418 batch, the rotor should be replaced. Cost of replacement will be reimbursed by DBA.
