Product Safety Recall

Xtreme Performance Clutch Kits

Sold between 1 August - 30 November 2021

Part numbers: KTY24009-1A, KTY24009-1B, KTY24009-1C, KTY24009-1T, KTY24509-1A, KTY24020-1A

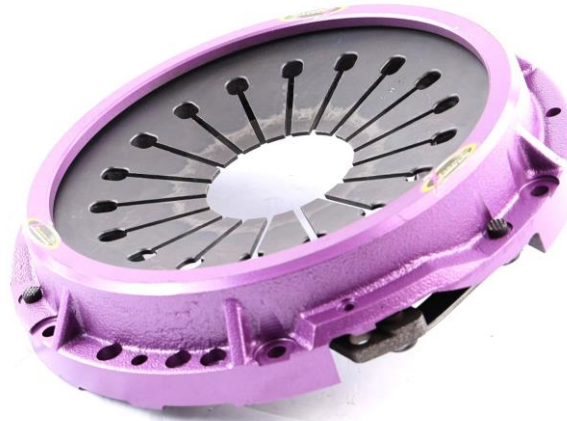
Defect: Due to an issue during manufacturing, the clutch kit may fail during use.

Hazard: If the clutch kit fails, it may increase the risk of an accident resulting in injury or death. It may also damage fuel lines, increasing the risk of fire.

What to do: Consumers with affected clutch kits have been contacted directly by Australian Clutch Services or their resellers. Consumers should immediately stop using the vehicle, and not restart the engine. Consumers should have the vehicle towed to a place of repair and contact Australian Clutch Services to arrange a replacement clutch kit.
