PRODUCT SAFETY RECALL

Telwater Pty Ltd - Stacer Navigation Light Mounting Plate Sold at Stacer dealers & other boat retailers nationally

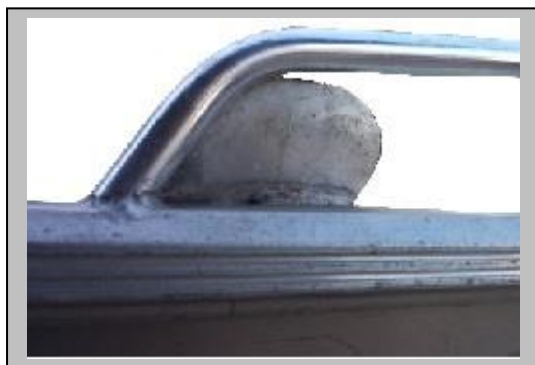
Navigation light mounting plate situated within the bow rail and fitted to some Stacer boat models manufactured between 17 August 2005 and 6 February 2012. Refer to photo for style.

In some circumstances it may be possible for a person's finger to be caught between the edge of the navigation light mounting plate and the bow rail tube.

If the defect occurs, the edge of the navigation light mounting plate may cause cuts or serious injury to the trapped finger.

Consumers should immediately stop using the boat and check the style of navigation light mounting plate against the example picture.

For further information customers should contact their nearest Stacer dealer to arrange for inspection and rectification if necessary.
