# Product Safety Recall

## Klein Tools Non Contact Voltage Tester NCVT-1

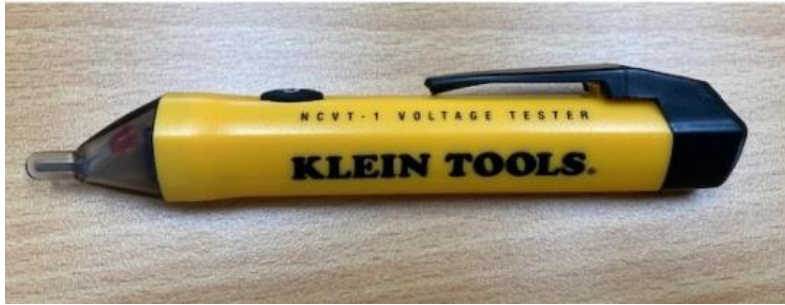
Product is marked with a date code ending in H7, ie. 'XXXXX'-H7  
Only batch H7 is affected by this recall

The green light on the tip of the tool remains on when the on/off button is depressed, indicating the tool is “ready to detect voltage,” when it is not.

If a user believes the tool is ready to detect voltage when it is not, they may not get an accurate voltage reading, increasing the risk of electric shock.

Check the date code of your tester to see if it is affected. If you have the affected tester, immediately stop using the tester and contact Klein Tools Australia to arrange for a replacement or return the product to the place of purchase for a full refund.
