# Product Safety Recall

## Glass Pool Fence Latch

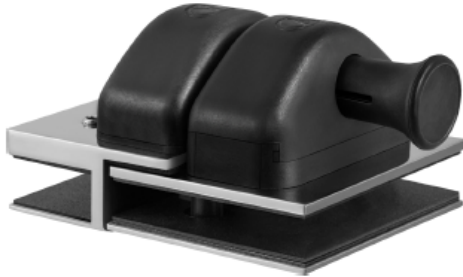
**DESCRIPTION:** Polymer plastic glass gate latch part with 'A' logo and guide tabs

**DEFECT:** The gate latch guide tabs may break, stopping the engagement pin from retracting and connecting securely with the magnetic keeper. This will result in the gate not closing properly.

**HAZARD:** If the gate latch is not closed correctly and the gate remains unlatched, it may not prevent unsupervised access to the pool or spa area posing a risk of drowning.

**WHAT TO DO:** Consumers should ensure the gate is secured until a replacement latch has been installed.

Consumers should contact Aristo Glass Products Pty Ltd on 08 9418 8914 or email [admin@aristogroup.com.au](mailto:admin@aristogroup.com.au) for a replacement latch.
