5 February 2015

## SAFETY NOTICE

### PVE2035AT-11.2 MULTI-VALVE

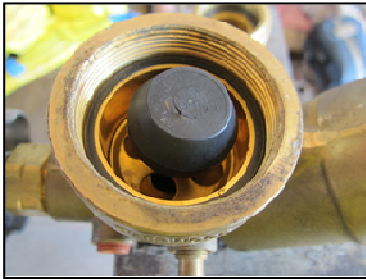
The leak occurs when the rubber material of the main fill valve seal separates from the brass poppet. The failure of the rubber bond to the brass poppet, may cause leakage of propane gas after the fill hose is disconnected from the valve, either immediately or shortly thereafter. See photos below for example of failure. The reported incidents have shown evidence of a gap at the top and the side of the poppet seal. (See photos).

Poppet seal in Valve

- Check the cylinder re-test date. If the cylinder was retested between 1 December 2013 and 6 February 2015 proceed as follows. If the cylinder was retested outside of that period no further action is needed.
- Prior to filling the cylinder, install a safety check valve, Sherwood part number PA901B, to the fill connection of the valve.
- The safety check valve (which utilizes a secondary check mechanism) **must be left in place until the valve is replaced** (generally at the next scheduled cylinder re-test cycle)

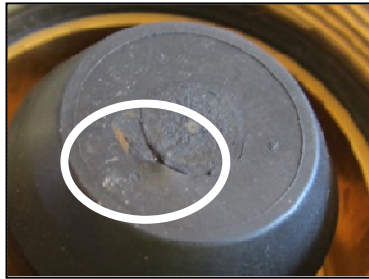
Separation of Rubber seal (Top)

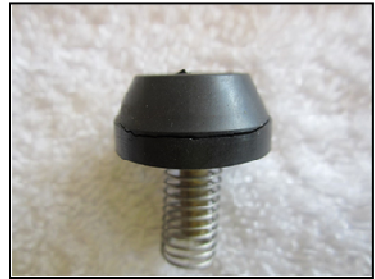
Separation of rubber seal (Side)
