# SAFETY RECALL NOTICE

## QUICK-RELEASE LEVERS

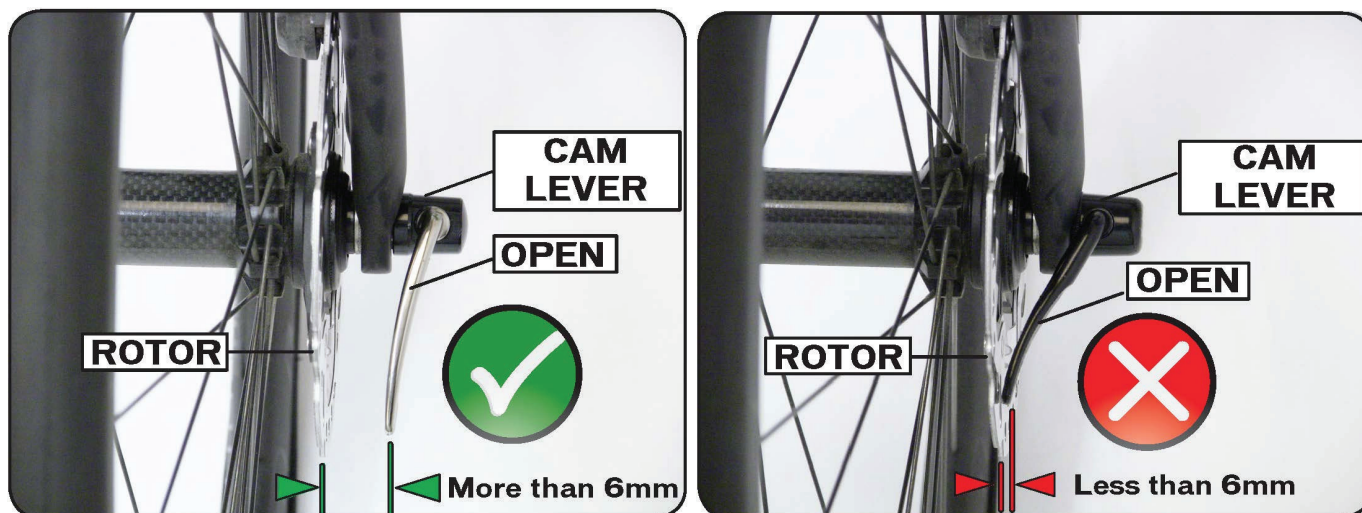
**Hazard:** Front-wheel quick-release cam levers that are improperly adjusted or left open during riding and do not meet the #2 Pencil Test below may potentially interfere with the front disc brake rotor, which could result in the rider losing control and sustaining serious personal injuries.

This is a Safety Recall Notice regarding all Model Year 2002 – 2015 Specialized bicycles equipped with front-wheel quick-releases and disc brakes where the space between the leading edge of the cam lever in its most open position and the disc brake rotor is less than 6 millimeters which is the equivalent of the width of a standard #2 pencil (the “#2 Pencil Test”). Please visit [www.quickrelease.com](http://www.quickrelease.com) for a visual demonstration of the #2 Pencil Test.

Fig1: Quick Release not affected by this recall

Fig2: Quick Release affected by this recall

**Remedy:** Stop riding the affected bicycle immediately and bring it to an Authorized Specialized Retailer, which will replace the affected quick-release free of charge. For any inquiries, see your local Authorized Specialized Retailer or contact Specialized Rider Care at:
